Comparison of Penetration Sealing Techniques for Polyethylene and Spray Applied Polyurea Geomembranes and Vapour Barriers.

Dave Martin. P. Eng., Quantum Technical Services Ltd.

Mike Smith P. Eng., Western Engineered Containment Ltd.

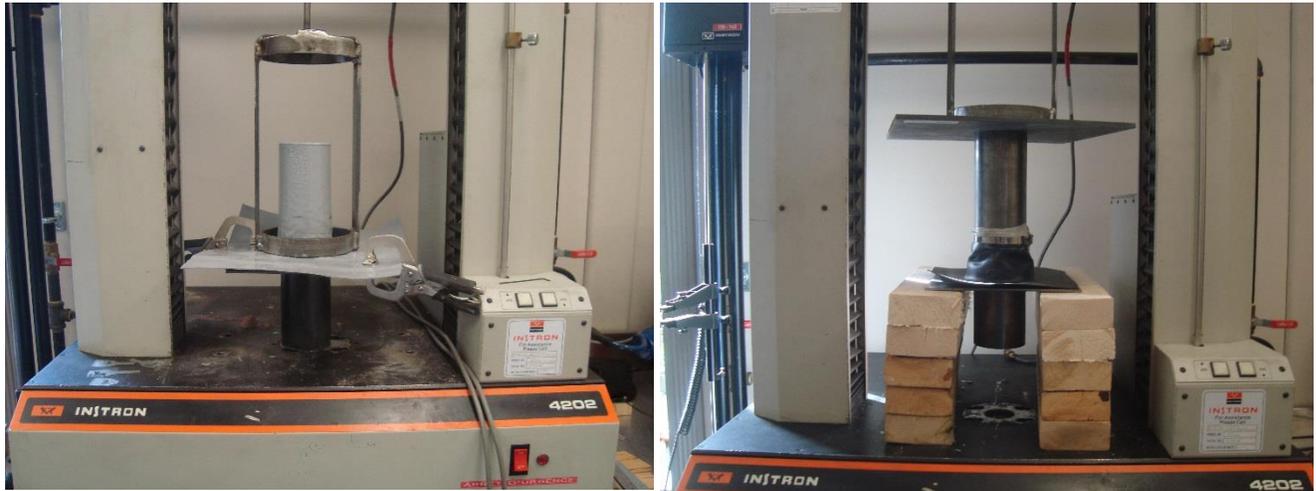
Apparatus:

Configuration for pressing the connection downward.

Configuration for pressing connection upward.

The connections were constructed on a 12" section of 3" OD steel pipe, using techniques described below. The completed connections were mounted on a steel plate with a 3 & 3/8" hole in the middle, with the pipe passing through the hole. A force was exerted on a connection to move it downward along the pipe, simulating ground settlement (under load) relative to the penetration; the force was exerted until the connection failed. In a second test, force was exerted to move a connection upward along the pipe, simulating ground heave relative to the penetration. Again, the force was exerted until the connection failed. The force and displacement required to break the seal of the penetration was documented; the seal break was confirmed by water test when a clear break was not visually observable. Force was applied to the connections using a custom-made jig, and an Instron model 4202 Tensile Machine.

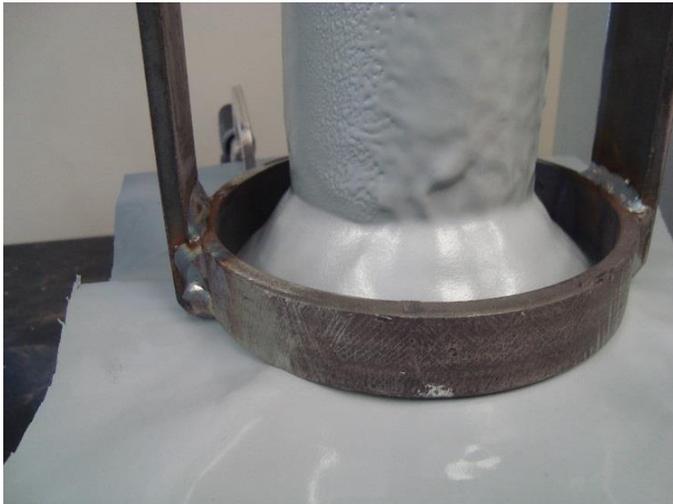
Stretching of Polyurea Boot Prior to Failure

Polyurea Connection	1	3800 (854)	50	Small region of connection between pipe and first 10 mm of skirt stretched until it broke. Area affixed to pipe did not move or separate.
	2	2800 (629)	38	Same as Polyurea Sample 1
Tape Connection	1	200 (45)	Immediate	Holes appeared immediately, 25 mm required to dislodge tape.
	2	126 (28.3)	Immediate	Same as Tape Sample 1

The polyurea connection gave the strongest bond to the metal pipe, requiring much more force than with the polyethylene to displace the connection, and even under maximum force, the bond between the polyurea and the pipe was not compromised. The actual displacement to failure was similar to the average of the polyethylene pipe boot, but there was no case of rapid failure as when the caulking seal at the top of the boot was broken. Displacement was influenced by the lack of slack material allowed to stretch in our experimental configuration. Polyurea is actually a very stretchy material, and in an actual installation, the forces on the connection would be spread over a greater area. The complexity of installation is much lower with a spray-applied material, and the variation in performance between connections, even in more complex configurations, would be less than a polyethylene constructed pipe boot. Spray-applied connections are easily repaired with addition of more material. The added containment security and reduced/eliminated maintenance of the polyurea connection would be a factor in justifying the cost. In applications where there are many closely spaced penetrations, or complex in structure, the installed overall cost of polyurea may be lower than less expensive sheet goods.

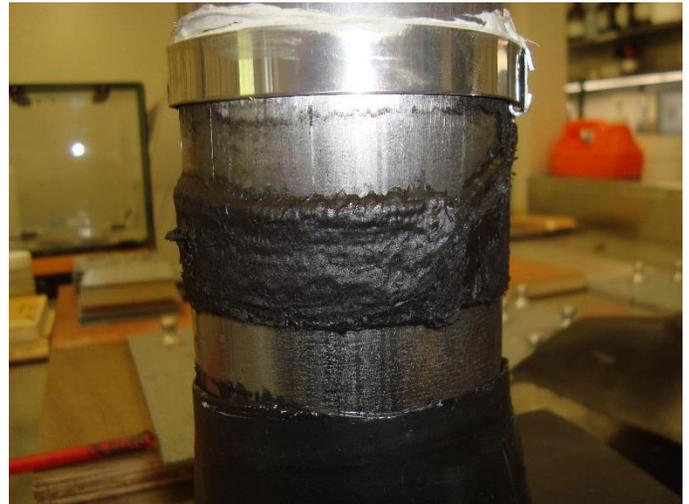
Failure of polyethylene boot Sample 2

Attachment	Force To Break Seal N (lbf)	Displacement to Break Seal (mm)	Failure mode
Polyethylene Pipe Boot (Technician 1) 1	360 (81)	47 (seal not broken)	Clamp ring slid down, smearing butyl caulking with it. No seal failure when test stopped
(Technician 1) 2	180 (40.5)	40 (seal completely failed)	Pipe boot slid out of clamp, clamp did not move. Butyl caulking slid down with the boot for a short distance before complete failure.
(Technician 2) 3	2000 (449)	62	Same as sample 1, pipe boot eventually broke at base
(Technician 2) 4	1500 (337)	11	Clamp ring slid down with pipe boot, but once urethane caulking at top broke a small leak appeared

The polyethylene pipe boots showed inconsistency in their performance. This variation occurred within boots prepared by the same Technician, and between one Technician and another. With downward force the boots slid rather easily (40 to 80 lbf) in one set of samples but showed more resistance (350 to

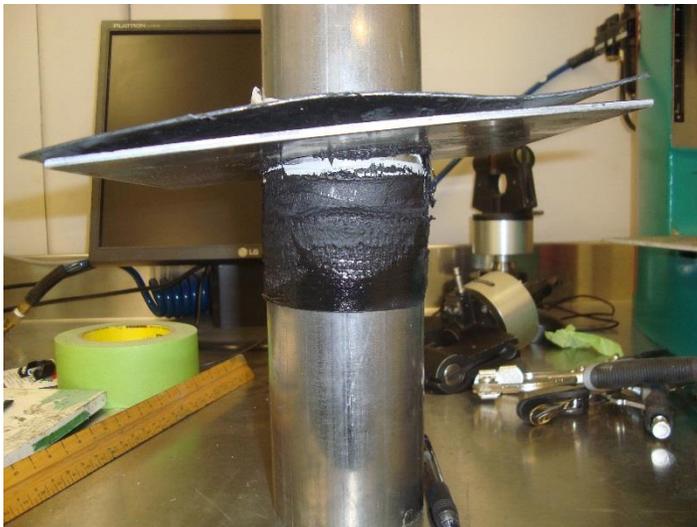
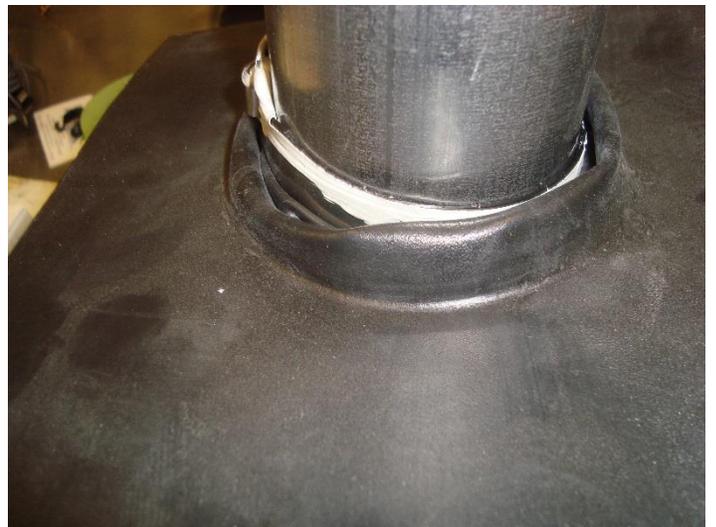
Polyethylene pipe boot pushed upwards to failure

Attachment		Force To Break Seal N (lbf)	Displacement to Break Seal (mm)	Failure mode
Polyethylene Pipe Boot	1	850 (191)	48 (approx., ring did not slide up evenly)	Water test required to detect leak, see picture
	2	850 (191)	48 (approx., ring did not slide up evenly)	Sample as Polyethylene Sample 1
Polyurea Connection	1	Off Scale	35 (approx.)	Steel plate tore the polyurea because of lack of clearance polyurea unable to slide upwards.

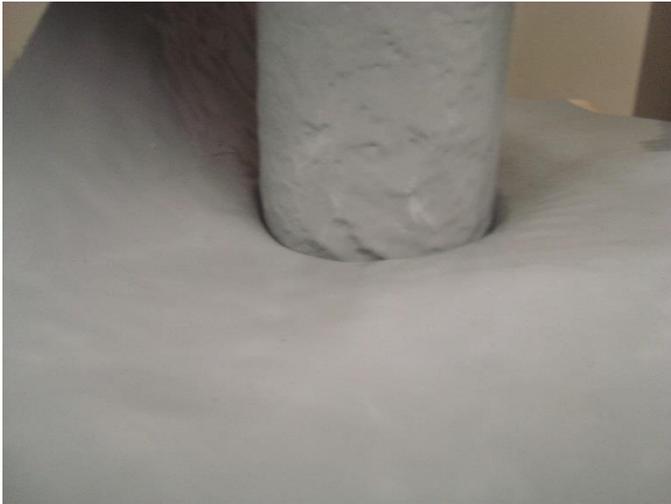
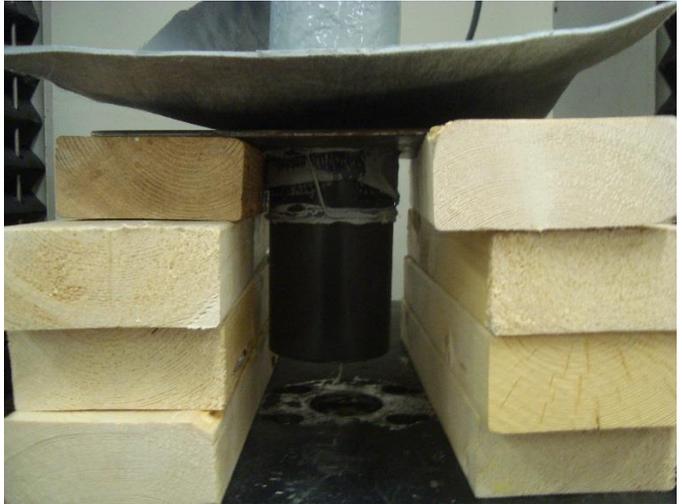
Polyurea connection pushed upwards to failure

2	6000 (1348)	46.9	Water test pinpointed seal break accurately.
Tape Connection	1	80 (18)	Immediate	Holes appeared immediately.
	2	165 (37)	13.8	Extra tape added to better cover edge of cuts in film. Holes appeared at 13.8 mm, 247 N (55.5 lbf) was maximum strength of tape connection.

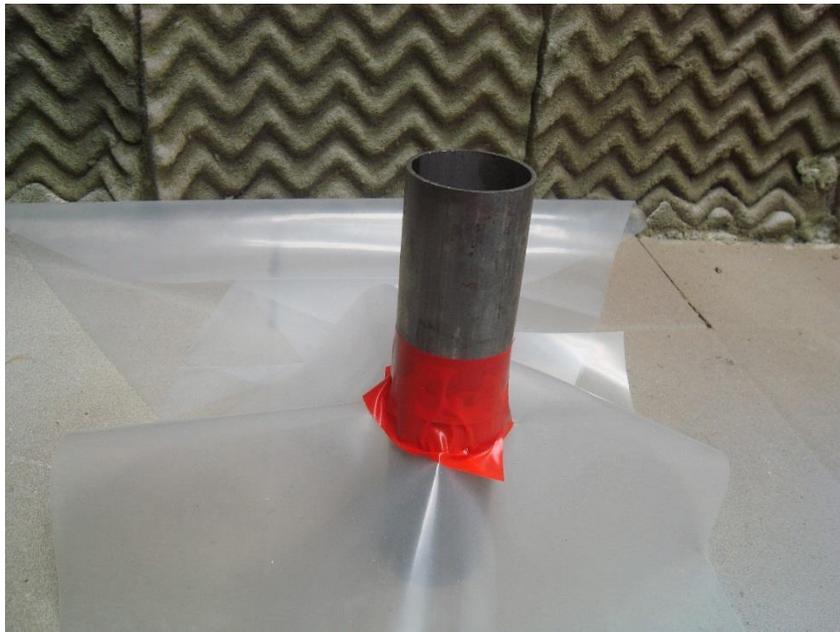
Tape Connection

Tape connections are obviously by far the easiest and least expensive to install. Requiring little experience, they can be done by a contractor installing an under-slab vapour barrier. The tape sticks reasonably well to the polyethylene sheet but the seal cannot withstand much force before it is compromised and containment integrity is compromised. For critical containments for dangerous soil gasses, hydrocarbons and chemicals, spray-applied polyurea geomembranes should receive consideration when designing a containment system.
